# CONTAINER LESSONS

## The forces that caused the MSC Zoe accident explained

**In the night of January 1 2019, the large container vessel MSC Zoe sailed the southern shipping route above the Wadden Islands into a northwesterly storm. The ship lost 345 containers, which led to big scale pollution of the sea and Wadden Islands. The subsequent safety investigation was to answer two central questions: What could have caused the loss of the containers above the Wadden Islands and how can we prevent this in the future?**

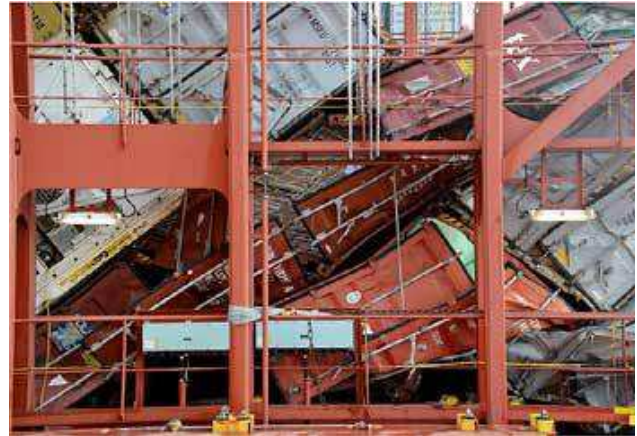
Crushed containers on board MSC Zoe (source DSB).

When the day broke, the crew started to gain a clearer picture of the situation on deck and saw that more containers were missing, including two of the three containers with hazardous substances. The crew also found various loose parts of the lashings, including the tensioners from the lashing rods, hooks and locking pins, and twistlocks that were broken in two. When MSC Zoe was moored at Bremerhaven, a detailed picture of the damage showed that 345 containers were lost. Another 450 were damaged.

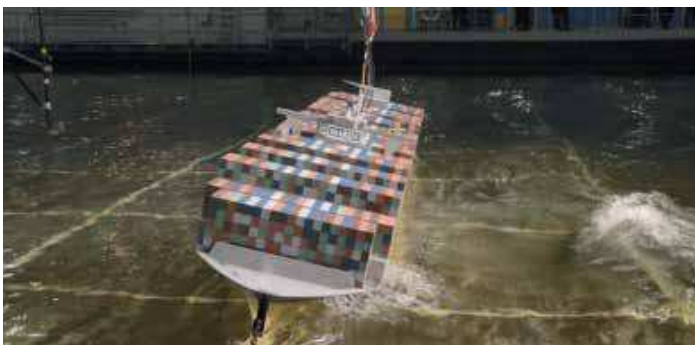
Image of the ship model at the moment of occurrence of a wave impact against the bow and a breaking wave close to the ship (source MARIN).

4. **Slamming:** The short (breaking) waves along the Dutch coast in the tested conditions resulted in wave-induced slamming against the side of the ship, particularly in wave heights of 6.5 metres and above. This slamming can result in vibrations of the

ship hull, container movement and extreme loads on their lashings, which can cause them to fail. The large wave impacts on the ship's side occurred approximately twice as often as the green water events in the three hours of exposure during the tests. In deeper water slamming was also observed, but the frequency of slamming reduces with increased water depth.

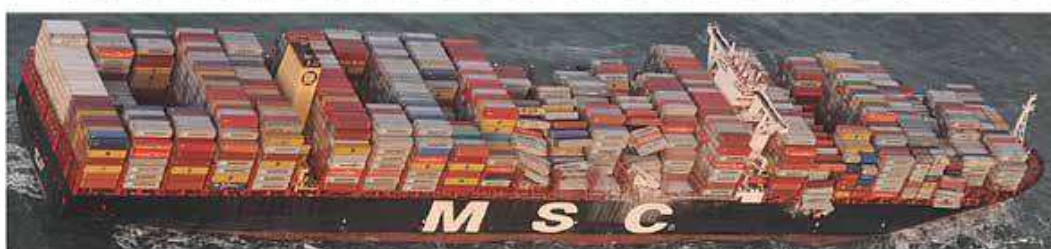
Green water observations along the ship's length.

3. **Green water:** The shallow water beam waves during the storm can have a high horizontal velocity and can be close to breaking. When these waves hit the ship in shallow water, the wave energy cannot flow underneath the ship and finds its way up the side, resulting in a water jet of substantial velocity that may reach the main deck (eighteen metres above the waterline!), where the containers are located. This pulse of green water can hit the underside of the lowest row of containers, as well as the side of the containers at higher levels and can cause damage to both containers and their lashings. When one container is damaged or its lashings fail, a complete stack of containers can collapse and even a domino effect can occur that can push over a complete row. The tests of MARIN showed that the cargo area around the wheelhouse, from approximately four container bays behind to two container bays in front, was most exposed to green water. This is also the area where most of the containers of the MSC Zoe were damaged or lost. Although no green water load measurements have been taken in the tests, this suggests that green water can play an important role in the loss of containers in the tested conditions.

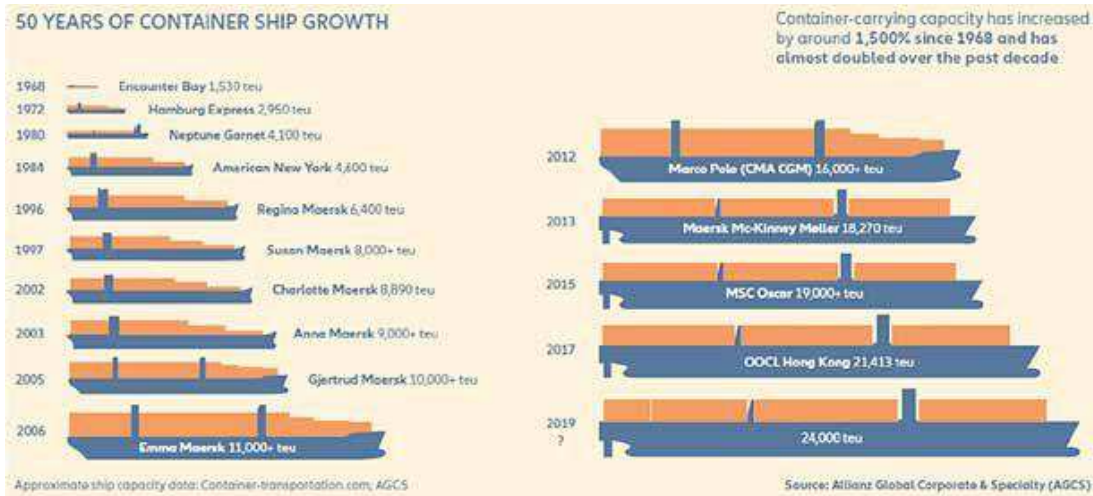
Container ship growth  
(source Safety &  
Shipping Review 2019,  
Allianz).

The international joint investigation report also points out that due to an increase in world trade, the capacity of container ships doubled over the past fifteen years. Where in 2005 a ship with a capacity of 10,000 containers was called an ultra large container ship (ULCS), recent ships can carry over 20,000 containers. The vessels have grown in size, for example length and beam, but also in stack height. This resulted in container ships carrying more containers on deck.
